**Netherlands East Africa
Dairy Partnership**

New Automatic Digital System Milk Collection Point

Los Cimaung-Indonesia

Friesian Flag Indonesia

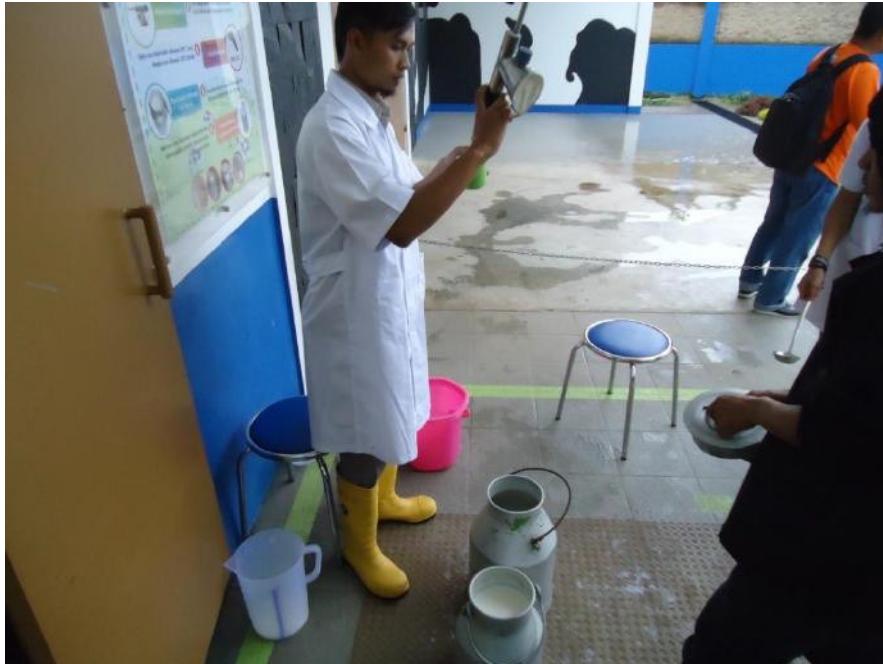
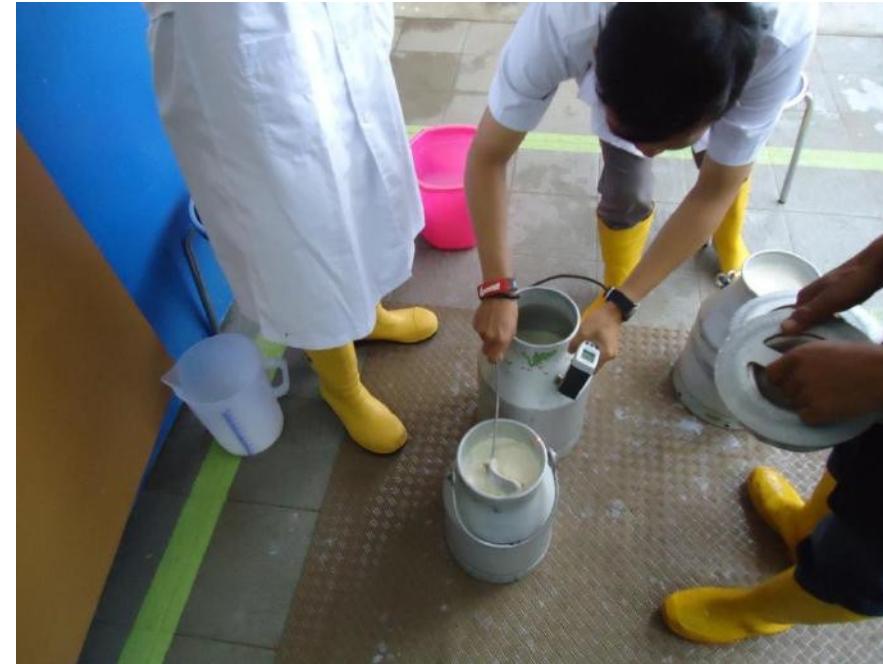
First check (outside the MCP on temperature and alcohol (75%)

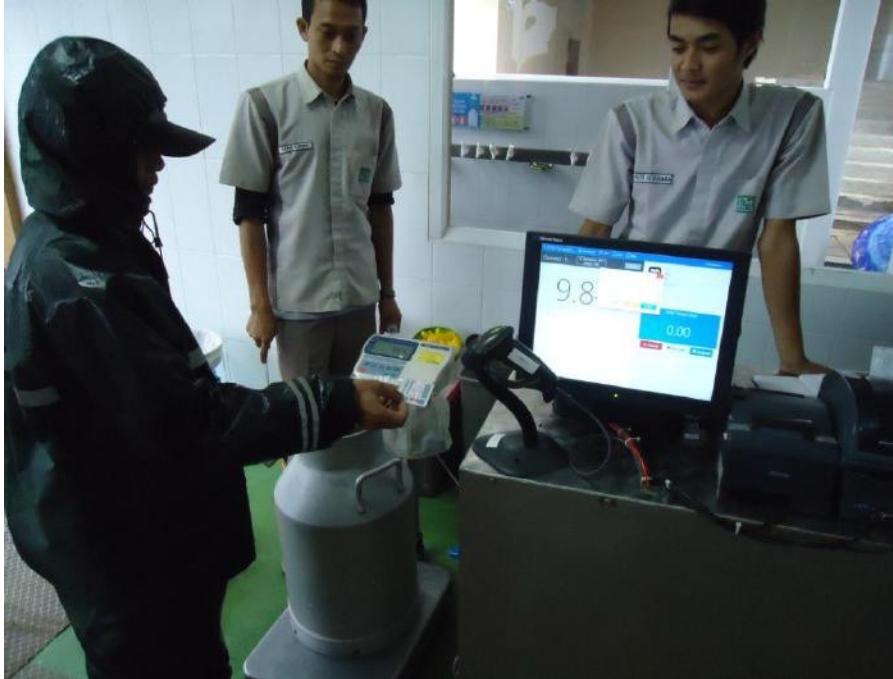
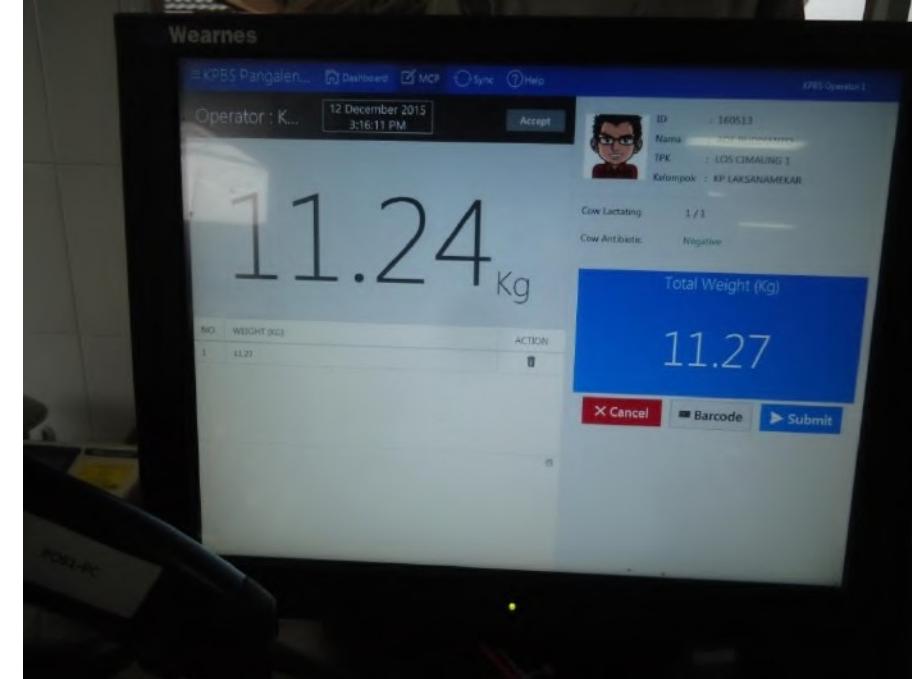
Identification of the farm by bar-coded ID card

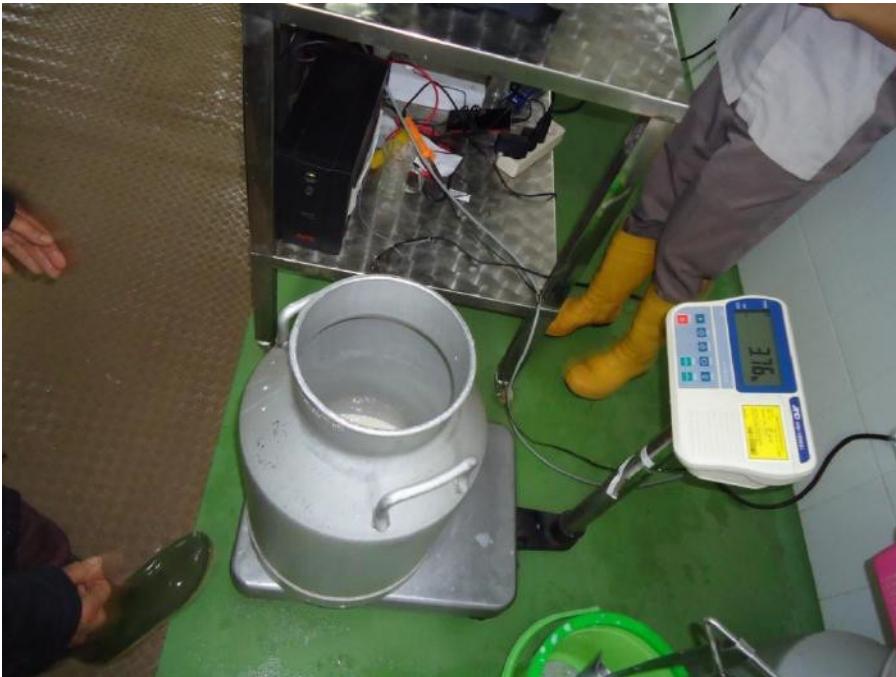
Kg measurement by electronic scale

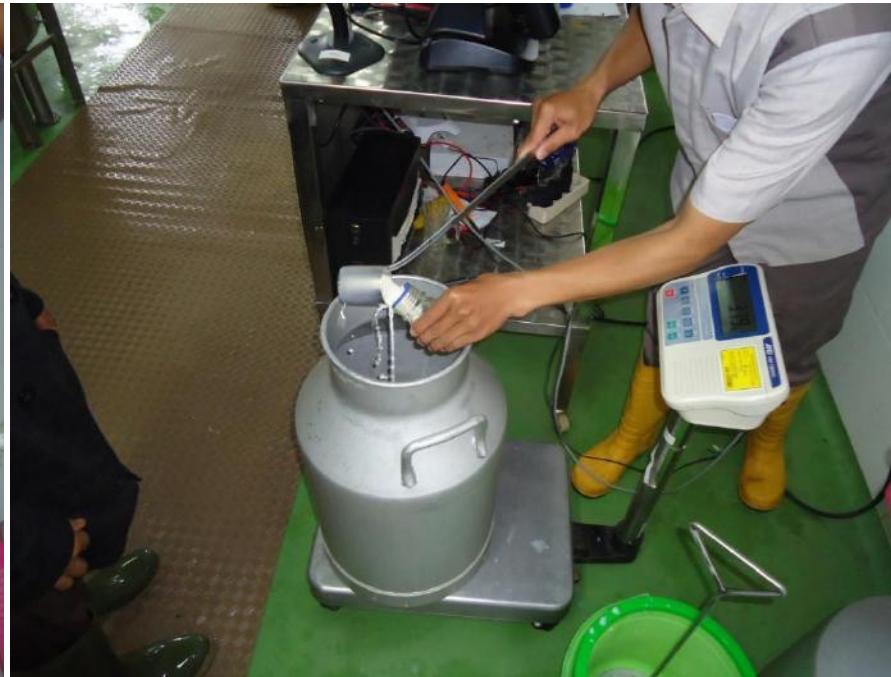
Individual sample for antibiotic testing
in case tank analysis indicates antibiotics
(tracing “wrong” farmer

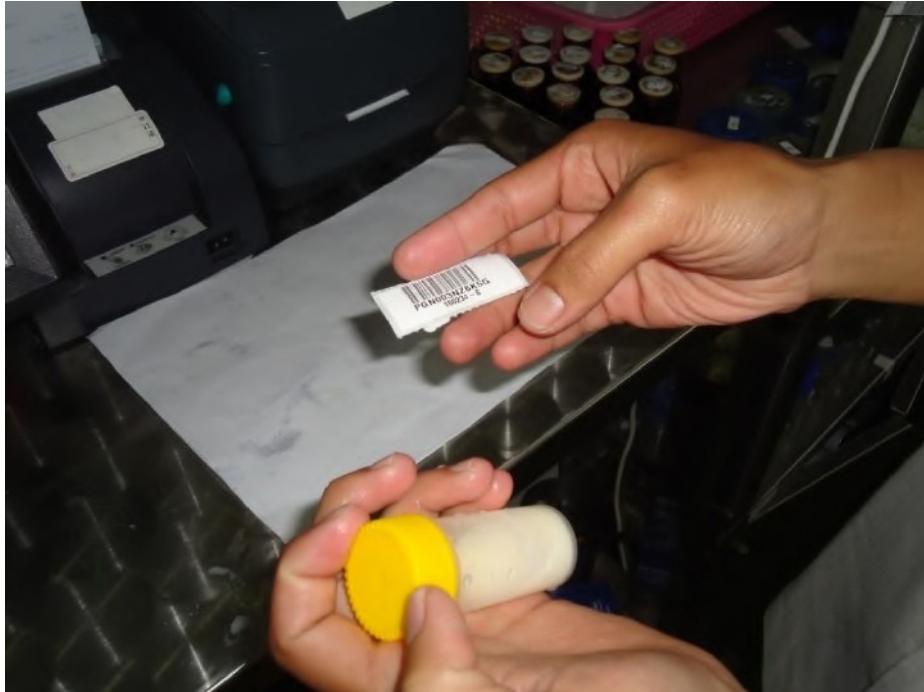
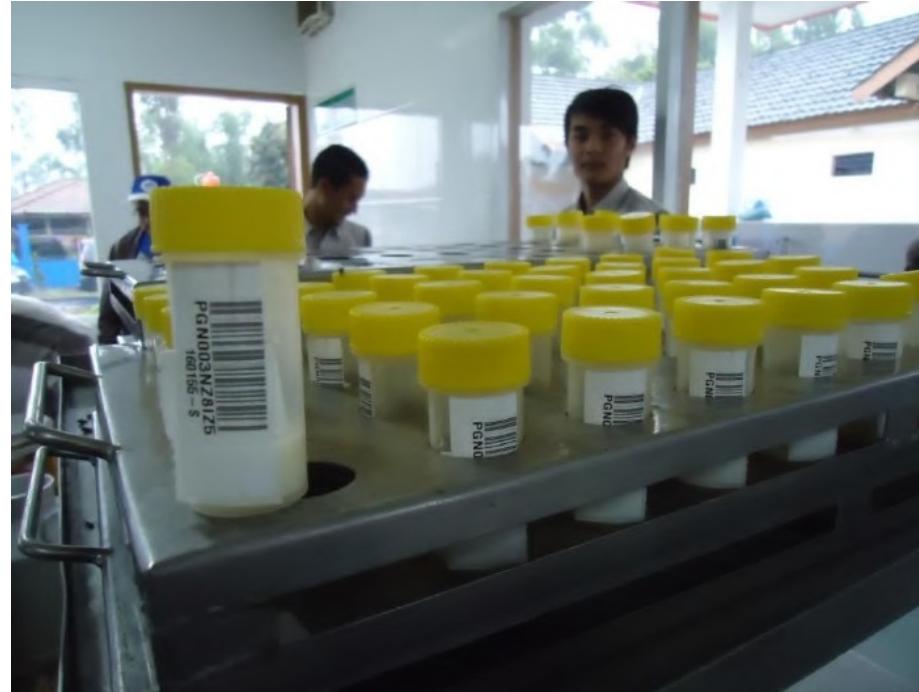
Barcode printer for putting barcode on sample taken

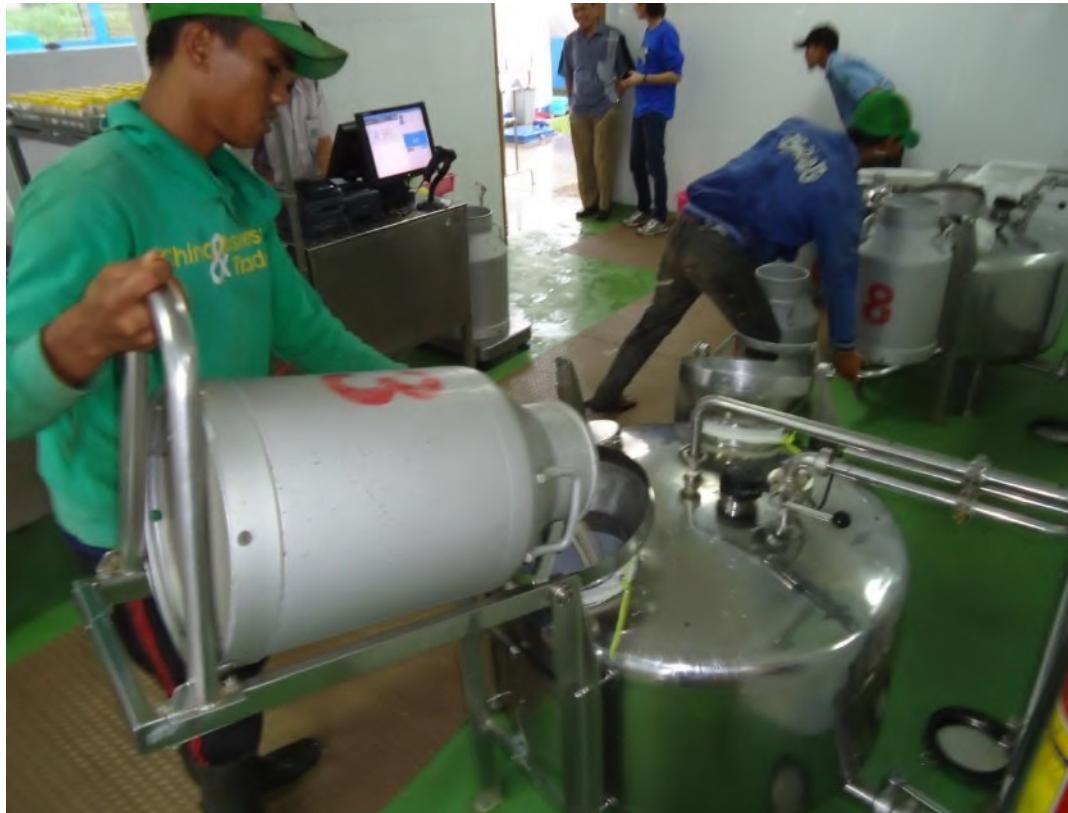
Putting milk into a dumping tank

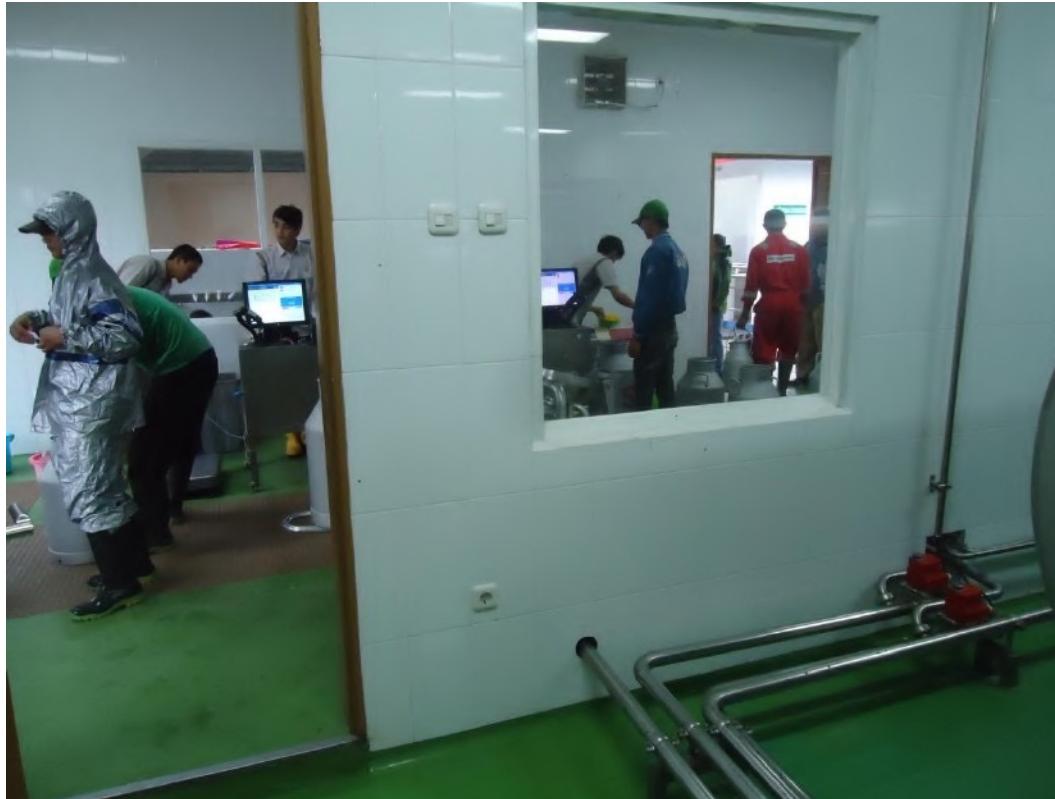
Milk reception in a separate room than the milk storage room

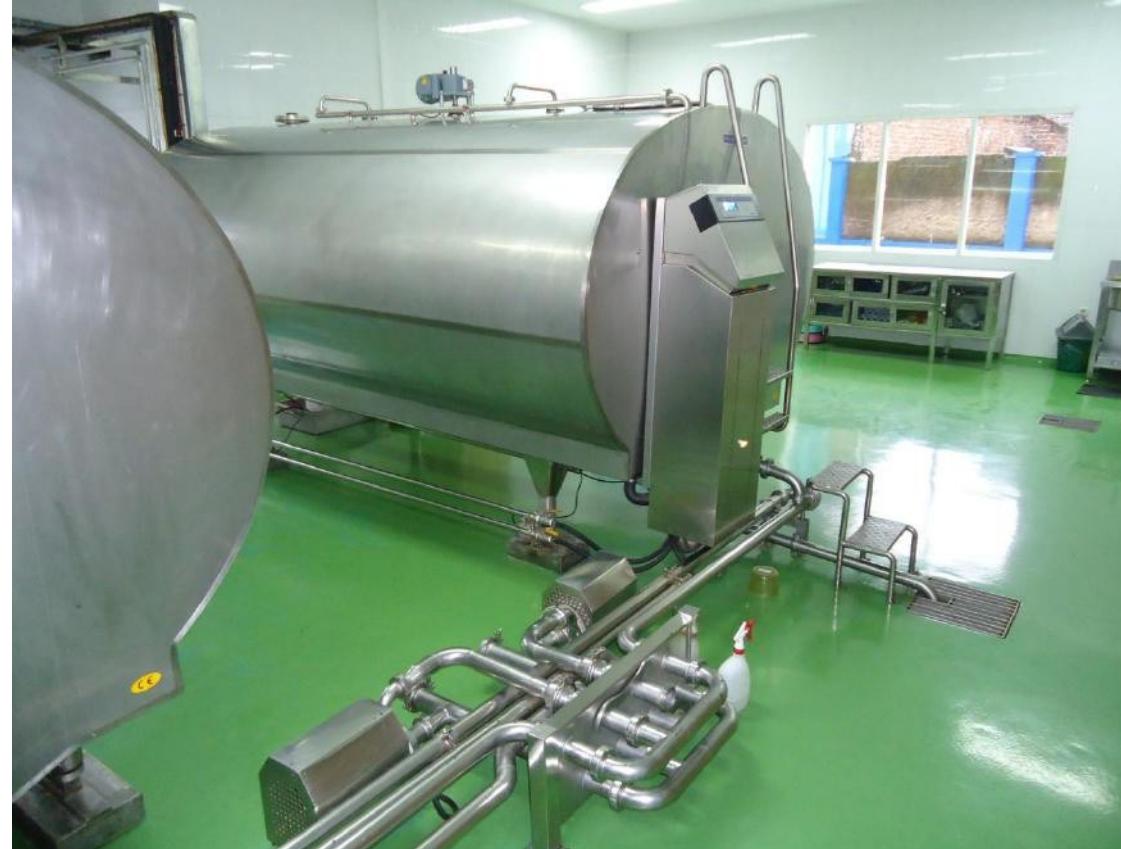
Milk storage room, with coated floor, tiles on the wall and smooth ceiling

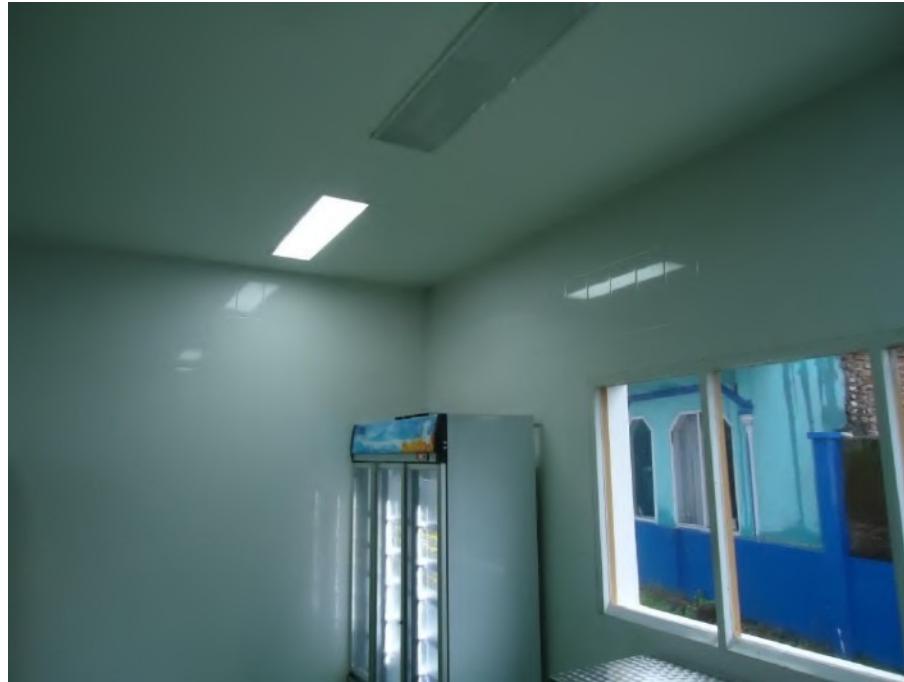
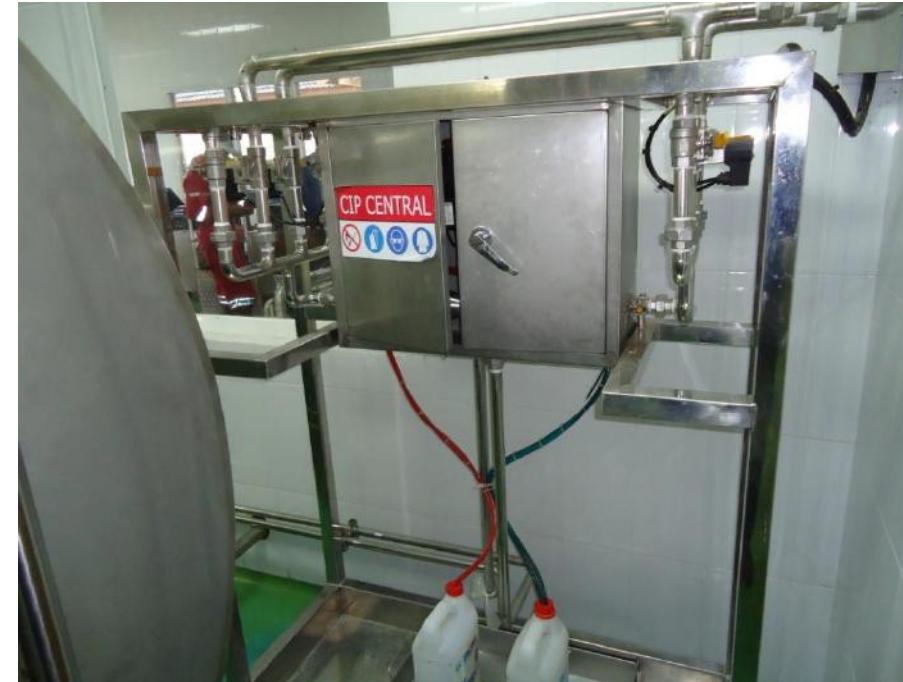
Milk storage room, with coated floor, tiles on the wall and smooth ceiling

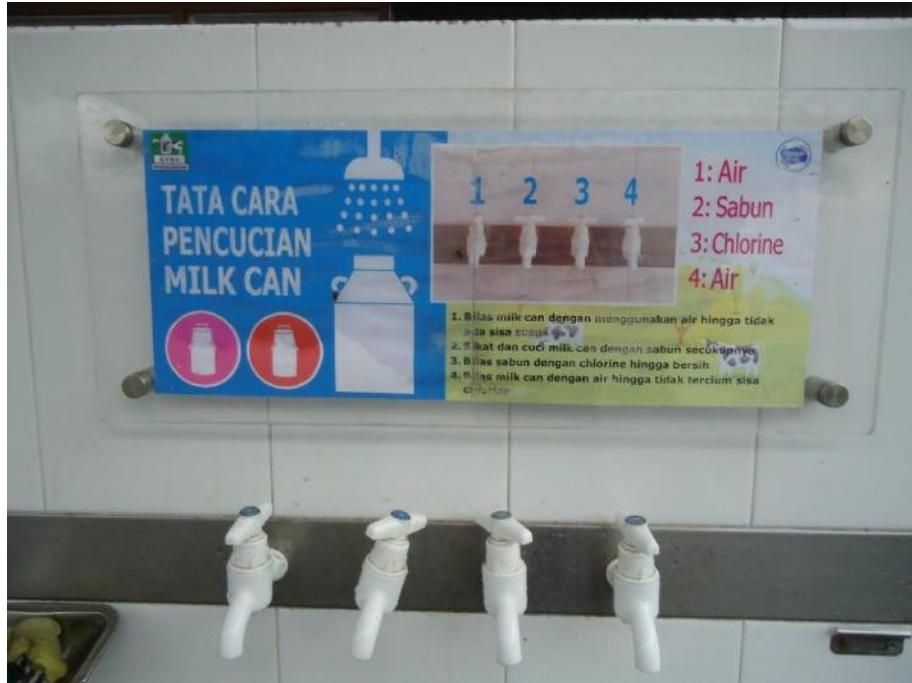
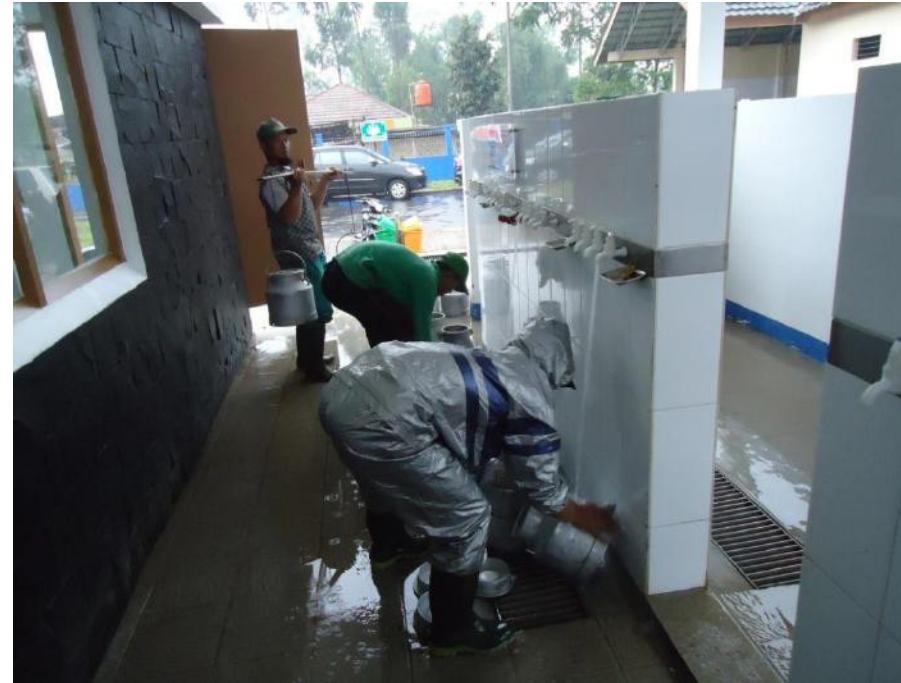
Compulsory cleaning of the milk cans by water, soap and chloride
